September 15, 2020

Re: Hadley Crossing - Garage Door Header Investigation
CDG Project Number 20066.00

INTRODUCTION

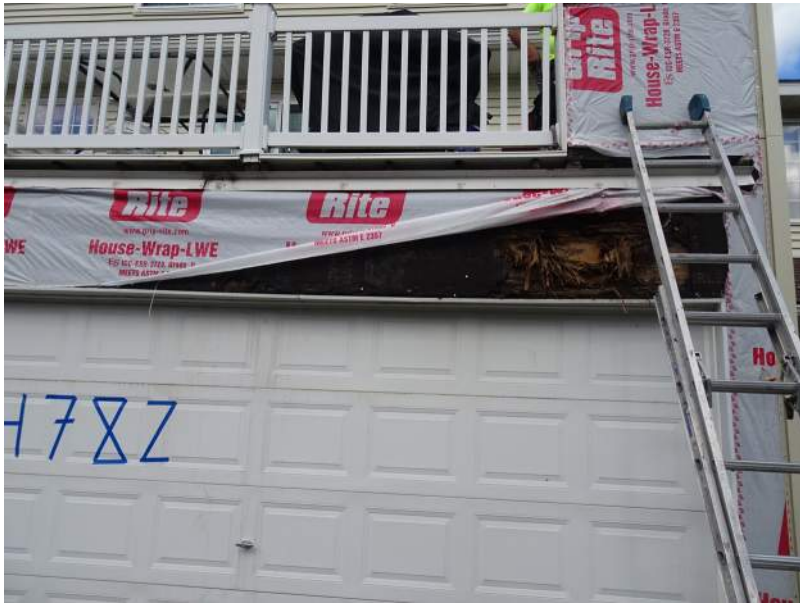
OBSERVATIONS	PHOTO
<p>1. The garage door header at some units has deteriorated due to water infiltration into the wall.</p>

1. Inspect the EPDM roofing at the edge of the decks on all units. Reseal all loose edges, disconnected wall flashing, and railing post boots. Replace missing or broken collars on rail post bases to shed water away from the boot seals.
2. At any unit that has EPDM repairs, remove the siding and inspect for water staining or dampness in the fiber board sheathing.
3. At any unit with water staining or damp sheathing, remove the sheathing to inspect the wood framing.
4. At any unit with deteriorated wood framing, make repairs using the details shown on the attached drawings SSK 01, SSK 02, and SSK 03. These drawings show the existing conditions, an option for replacing the headers with wood LVLs, and an option for replacing the headers with a steel beam, if desired.
5. Reassembly of the walls should include house wrap and ½" CDX plywood sheathing.

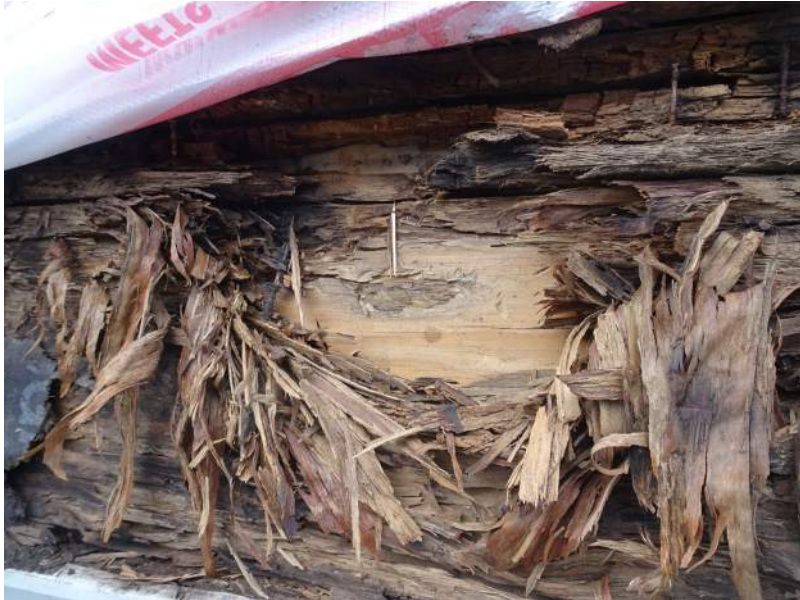
<p>2. The headers are constructed with (2) 1 3/4" x 14" LVLs.</p> <p>At the 4782 Unit, the outer LVL has severely deteriorated at the location of the deck railing post above. Minor deterioration of the inner header is also evident.</p>

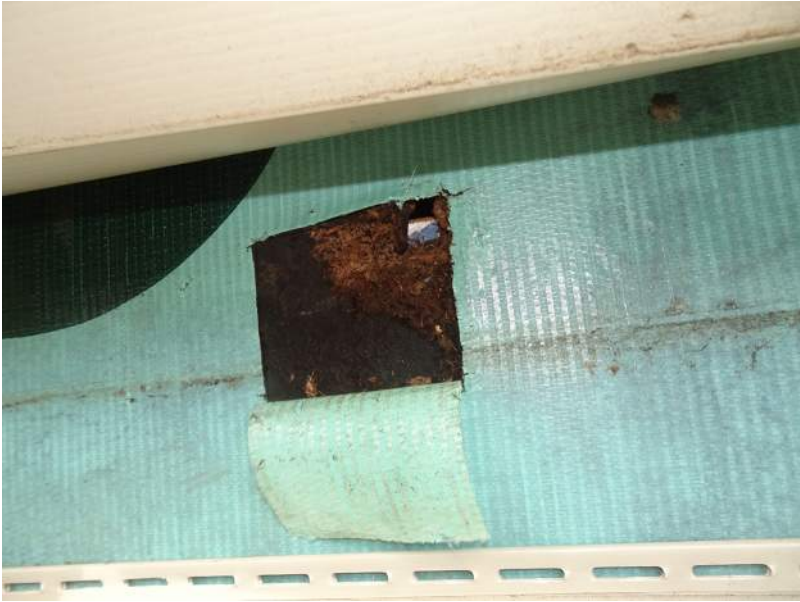
OBSERVATIONS	PHOTO
<p>5. The wood framing is covered by fiber board sheathing. This sheathing was found to be damp in many locations.</p>

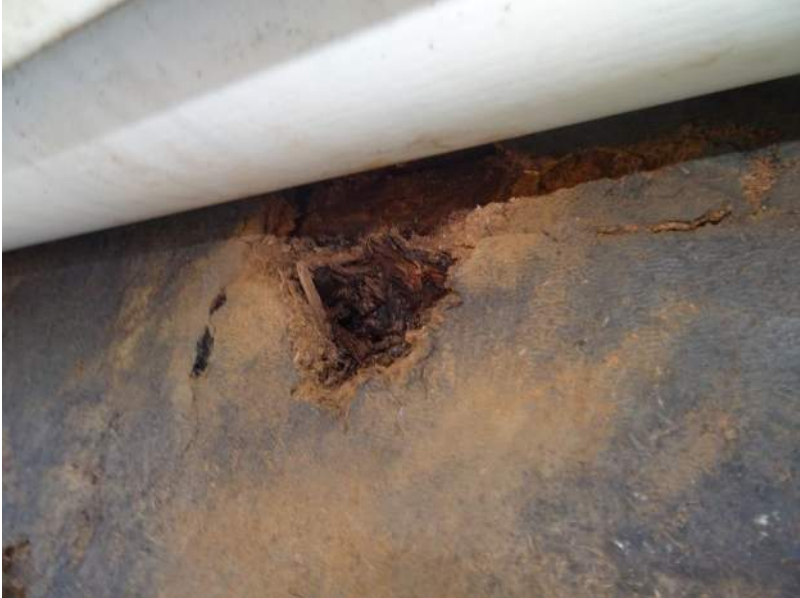
<p>6. The wood framing and headers behind the damp sheathing was observed to have some deterioration.</p>

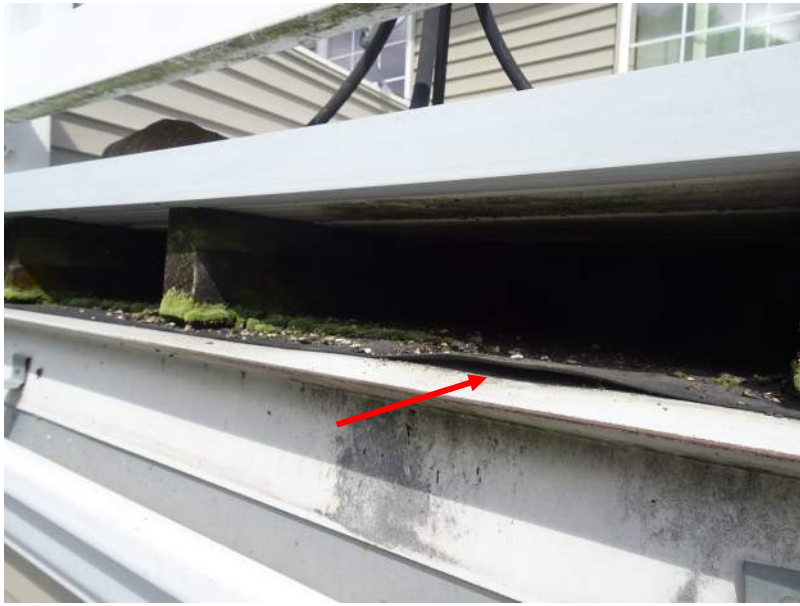
OBSERVATIONS	PHOTO
11. The edge of the membrane is not adhered well in many locations.

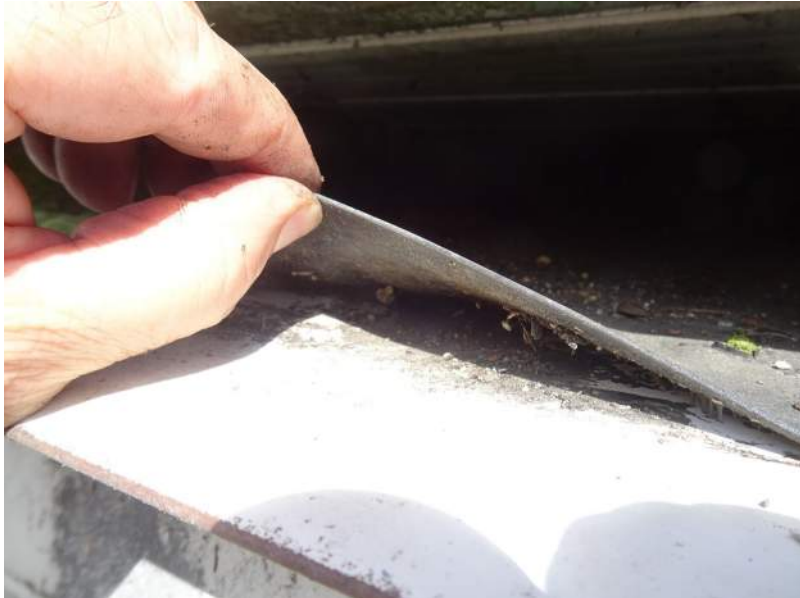
12. The edge of the membrane is not adhered well in many locations.

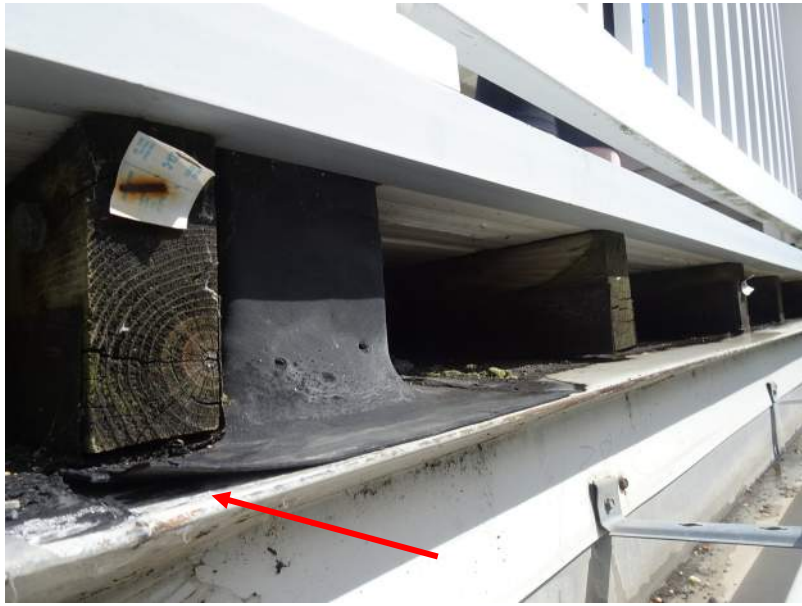
OBSERVATIONS	PHOTO
13. The edge of the membrane is not adhered well in many locations.

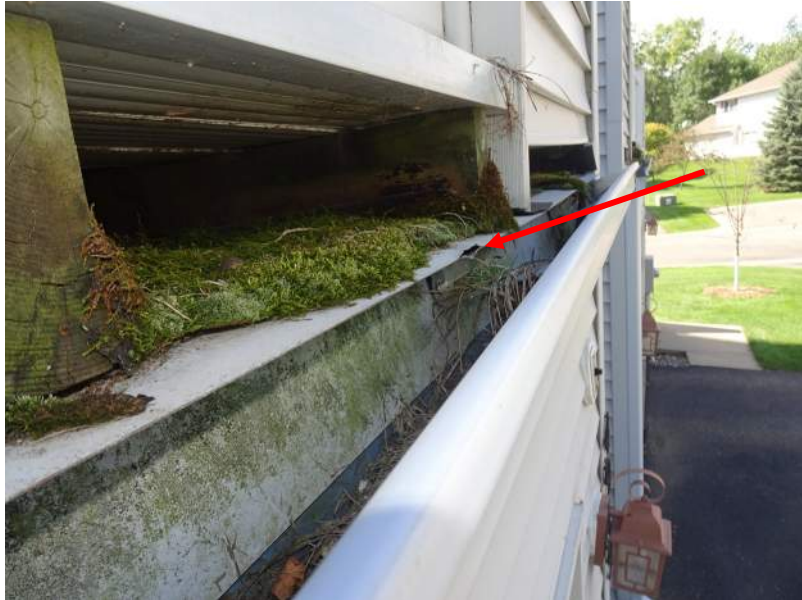
14. Holes in the edge flashing is allowing water infiltration.

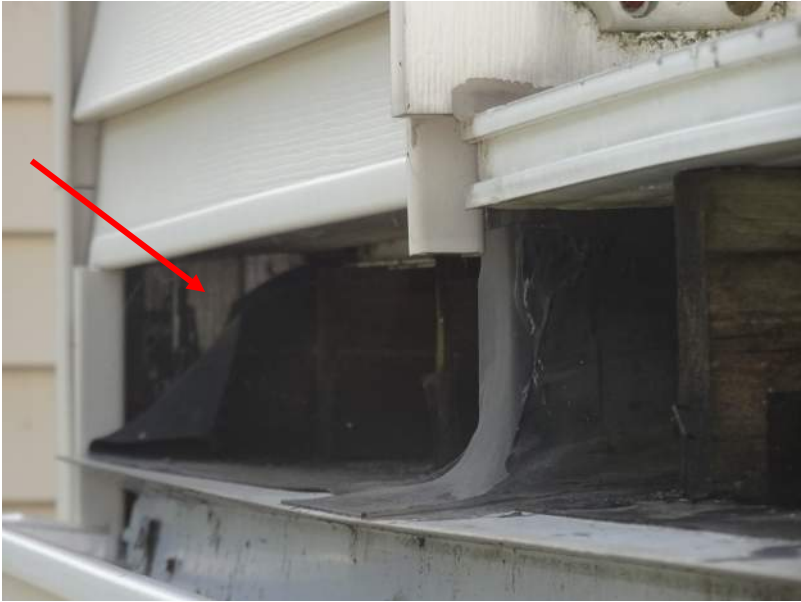
OBSERVATIONS	PHOTO
17. The EPDM membrane attachment at the walls has become loose in many locations.

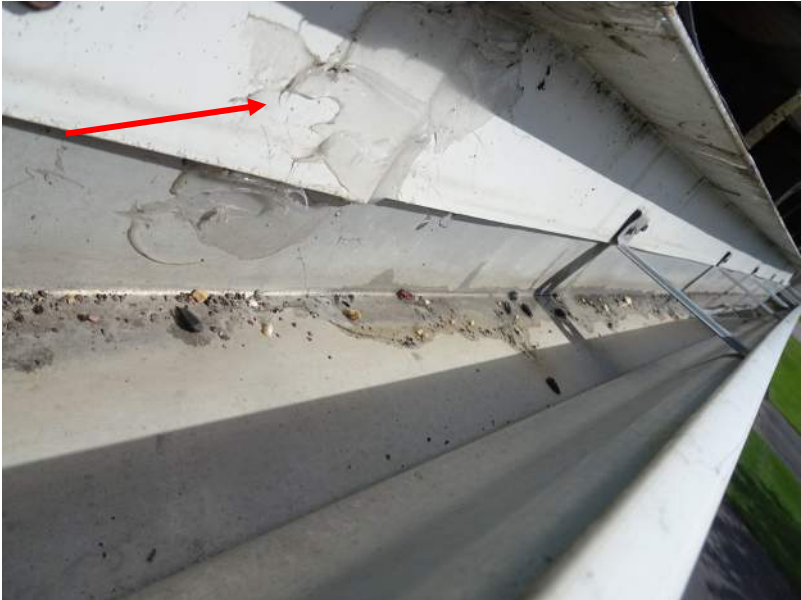
18. Some repairs appear to have been made with silicone sealant.
